"Full" Reserve Study

**Stadium Villas
Rockledge, FL**

**Report #: 34587-0
For Period Beginning: January 1, 2019
Expires: December 31, 2019**

Date Prepared: July 16, 2018

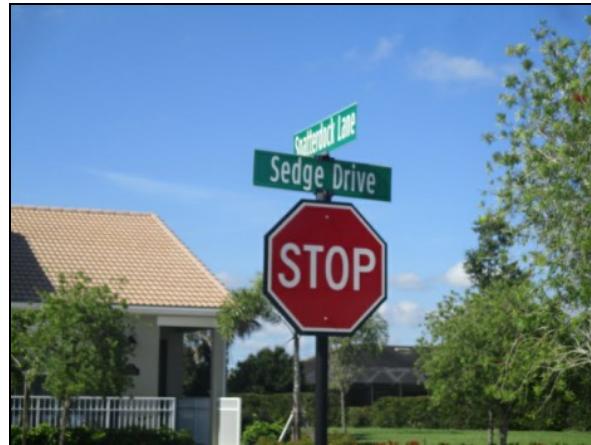
Street signs and posts are generally replaced at longer intervals due to weathering or style changes, or to coincide with other exterior projects such as replacement of entry signage, street lighting, etc. Signs should be inspected regularly to make sure visibility is adequate, including at night. Repair any damaged or leaning posts as needed. Costs for replacement can vary greatly depending on style selected; unless otherwise noted, costs shown here are based on replacement with a comparable type as are currently in place.

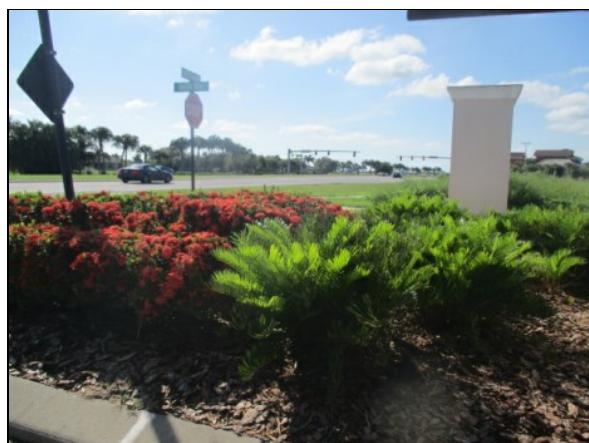
Evaluation: Landscaping costs are expected to be included in the Client's annual Operating budget. No recommendation for Reserve funding at this time. Monitor and include funding in Reserve Study updates if needed.

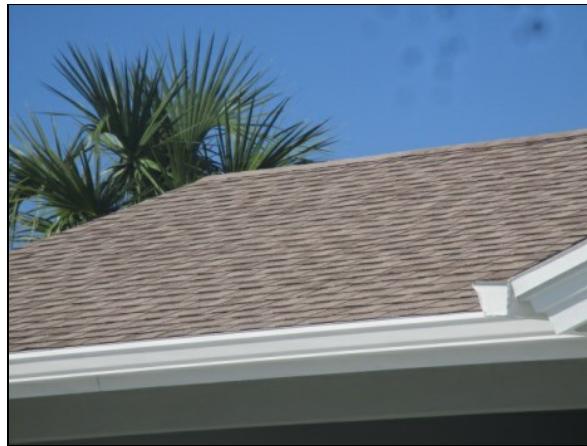
Evaluation: Approximately 1,750 GSF of shingle roof noted during site inspection. Fair condition: Asphalt shingle roofs determined to be in fair condition typically exhibit normal signs of wear and deterioration, including some loss of granule cover, and light to moderate curling/lifting, especially in most exposed areas. Overall believed to be aging normally. Dimensional shingles typically have longer useful lives and are generally considered to be more valuable from an aesthetic standpoint. We recommend budgeting to replace with dimensional shingles upon failure. Also known as architectural shingles, these types of roofs are typically more durable and wind-resistant than 3-tab shingles. Unless otherwise noted, costs shown here assume that only a minimal amount of substrate/decking repairs or replacement will be required. For very old roofs or those with significant leak problems, additional repair costs may be incurred. As routine maintenance, many manufacturers recommend inspections at least twice annually and after large storm events. Promptly replace any damaged/missing sections or conduct any other repair needed to ensure waterproof integrity of roof. Keep roof surface, gutters and downspouts clear and free of moss or debris. Moss growth can decrease the life of the roofing shingles and should be removed promptly. We recommend having roof inspected in greater detail (including conditions of sub-surface materials) by an independent roofing consultant prior to replacement. There is a wealth of information available through organizations such as the Roof Consultant Institute <http://www.rci-online.org/> and the National Roofing Contractors Association (NRCA) <http://www.nrca.net/>. If the roof has a warranty, be sure to review terms and conduct proper inspections/repairs as needed to keep warranty in force.

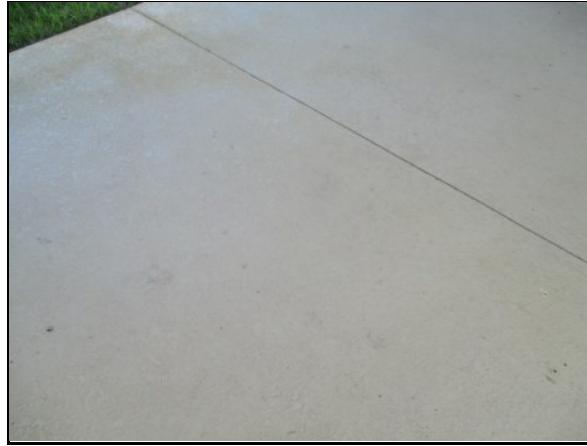
Pool decks may be exposed to harsh chemicals that can leave stains if not addressed properly. Periodic pressure-washing and re-coating will restore the appearance and prolong the need for major restoration or replacement of the deck surface. Take note of any places where water is ponding, which may result in slip-and-fall hazards if not corrected.

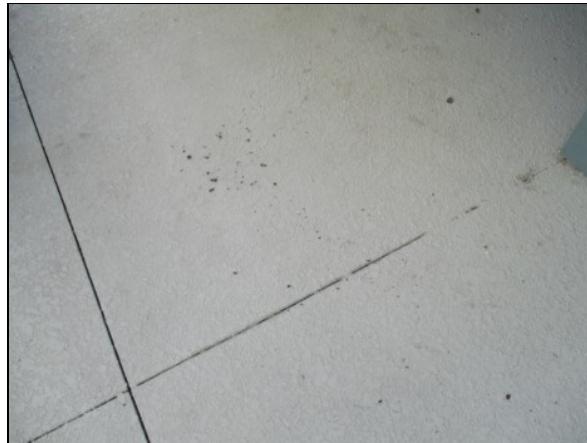
Evaluation: Refer to component #2767 for more general information and observations on conditions. This component refers to the eventual need to completely resurface/replace decking systems, typically required after multiple finish coats have been applied, or in cases of advanced deterioration. Resurfacing may also be warranted for changes in design/appearance alone.
